The Boise Parks and Recreation Department invited representatives of interest groups, agencies, private property and water rights holders to participate in the steering committee for the Boise River Resource Management and Master Plan project. The steering committee reflects the broad interests of the public. Its members identified issues, examined management choices, made policy choices and recommendations which will affect the Greenbelt path, the Boise River environment and future recreational opportunities.

Policy and Technical Recommendations

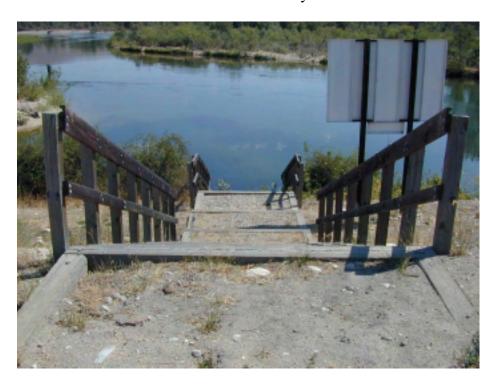
1 Barber Dam

The only marked portage in the planning area is around Barber Dam. This is a longer portage than most proposed portages in the planning area. It is well-designated with signs, however is difficult to use and should be made more user friendly.

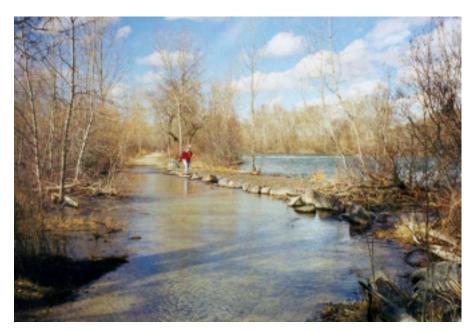
5 - 6 Wood Duck Island and Unpaved Path R-40, 41

The natural area and path on river left present institutional and management problems to be solved. A coordinated management approach should be adopted by the city and county as this area spans both jurisdictions. The path in the City of Boise has a deed restriction which prohibits bicycles. The Ada County portion is signed for pedestrian use and dogs on leash. There are many access points to the path. The alternate bike route, which meanders through the River Run and Spring Meadow subdivisions,

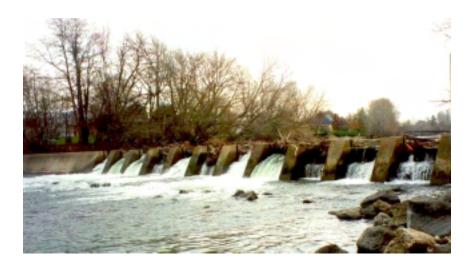
Settlers Irrigation District Diversion and Headgate

Settlers Irrigation Diversion is a key location in the planning area for several reasons. This diversion has been the traditional barrier which kept most tubers upstream, thus dividing the planning area into two river recreational zones based on the number and type of users. It is the top site for a potential kayak course. The hydraulics, in part caused by the diversion, are causing downstream erosion.

The Channel Assessment Report contains several suggestions including modifying the diversion for boater passage and building another weir downstream of the Settlers Irrigation diversion to trap sediment to cover a sewer line buried under the river, which is at risk of being exposed. A new diversion, properly shaped, would direct flow away from the right bank, ending some of the scouring action downstream.

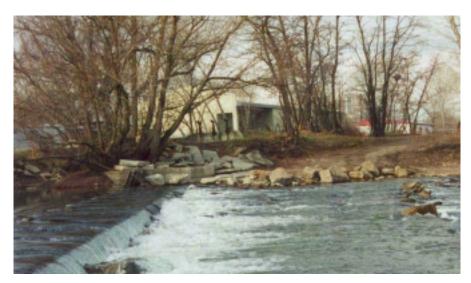
24 R-13 36th Street Wave/Thurman Mill Ditch Co. Diversion

The 36th Street wave is created by a rubble and concrete diversion owned by the Thurman Mill Ditch Co. and associated with a canal system on river left. The wave is popular with kayakers during flows of 6,000 cfs and more. At low flows there is exposed broken concrete and rubble and the diversion must be portaged on river left. The portage route necessitates crossing the concrete canal structure. An upgraded portage would improve safety. This is another choice for a kayak course, if modifications can be made to the diversion and access improved.

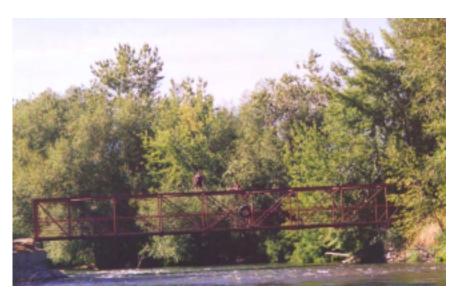
Garden City Greenbelt Bridges

The channel splits and there are bridges over both channels. Both bridges are undersized for flood events and should be evaluated for alteration or replacement. The bridge on the left channel is showing signs of failure. If the bridges were to fail, the Greenbelt path would be destroyed.
