## River Oaks Restoration Project 9000 South to 9400 South Jordan River

*Project by:*  
Sandy City  
West Jordan City

*Total Cost:* \$699,724  
*Completed* 2000

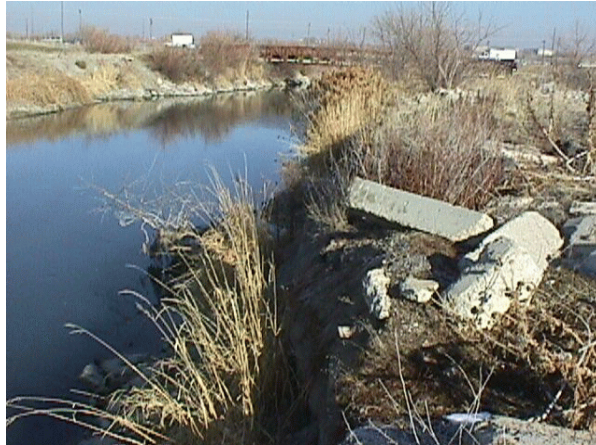
Vertical eroding banks and debris (upper photo) characterized this half-mile of riverbank. This restoration project was first to utilize the “emergent bench concept instead of the 3:1 graded slope. An emergent bench (photo at right) is graded to an elevation within 12” of spring high water to support establishment of native riparian and wetland vegetation and creates flood water storage. Excavated material stayed on-site to be re-contoured as berms separating the River Oaks Golf Course from the future Jordan River Parkway Trail. Two years later (lower photo) vegetation is well established and banks are stable.
